Manhole Inspection Summary

Manhole # S31KK1015MH

Insp Date: **2/26/07 1:21 PM**

Location Address: **4338 CHARLES ST**

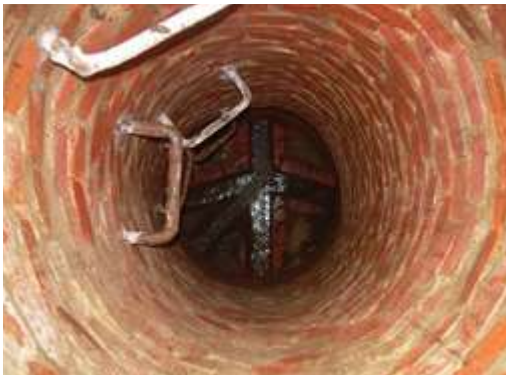
Top View

Adjustment infiltration. Corroded steps.
Bench debris.

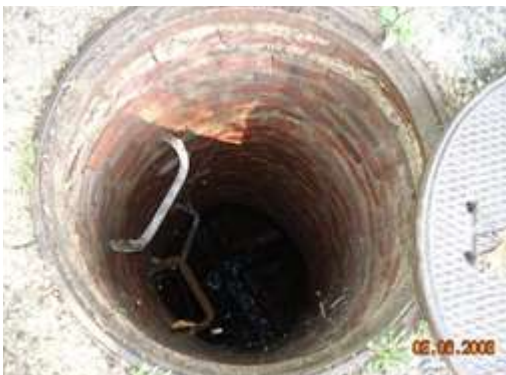
Defect

Infiltration: ☐ None ☒ **Joint** ☐ Cracks ☒ **Mortar** ☐ Roots ☐ Wall

Condition: ☐ Sound ☐ Cracked ☐ Root Intrusion ☒ **Deteriorated** ☐ Leaks ☐ Debris

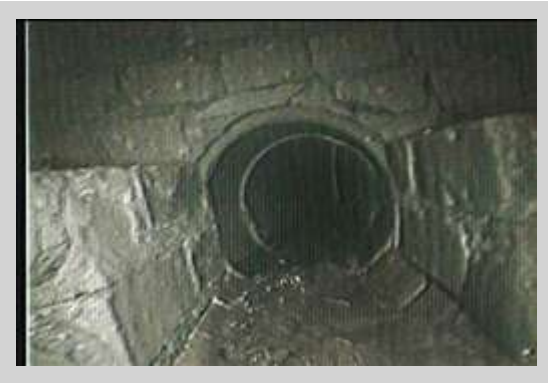
10 in. Circular Gravity Sewer Pipe Out @ 12 O'Clock

Channel deterioration.

Infiltration: **Evidence** Pipe Seal Cond: **Cracked**

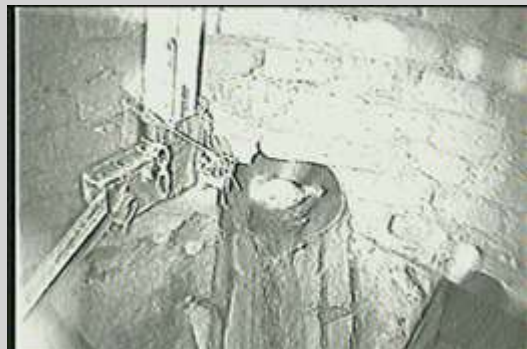
Pipe In @ 6 O'Clock

Infiltration: **Evidence**

Pipe Seal Cond: **Cracked**

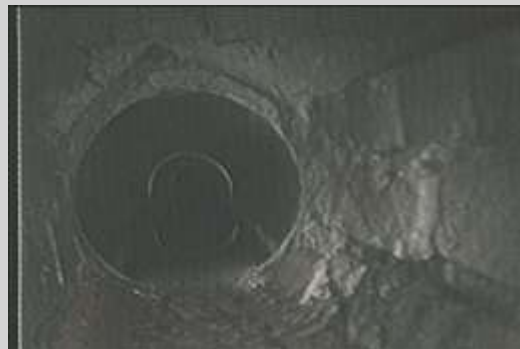
Pipe In @ 6 O'Clock

Channel deterioration.

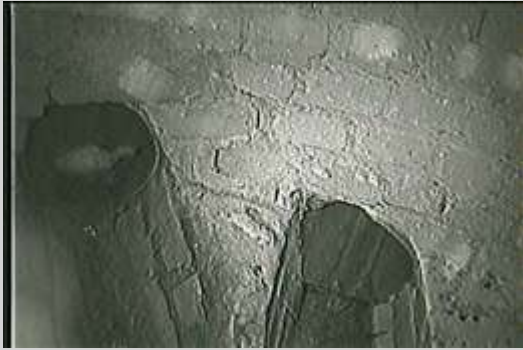
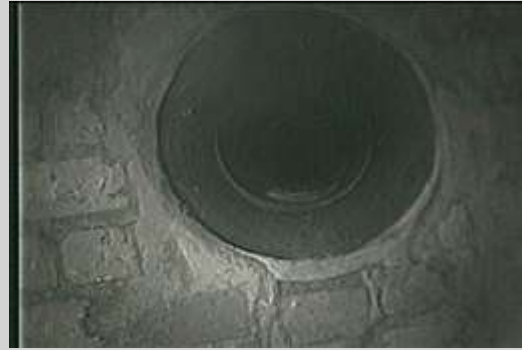
Pipe In @ 7 O'Clock

Pipe Seal Cond: **Cracked**
